**Tree Inventory and Preservation Plan Report
Melbourne Avenue and Dufferin Street
Toronto, Ontario**

17 March 2022, revised 30 June 2022

KUNTZ FORESTRY CONSULTING INC Project P3103

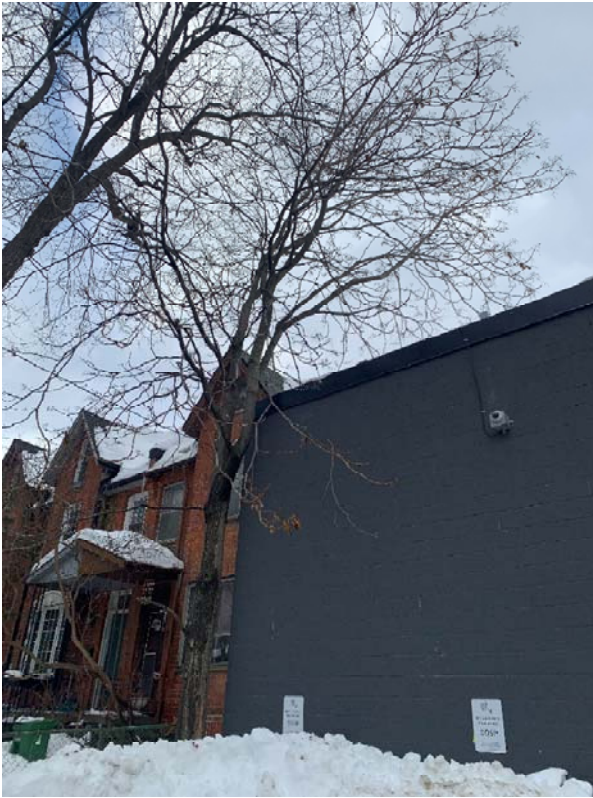
Image 1. Tree 1

Tree #	Common Name	Scientific Name	DBH	TI	CS	CV	CDB	DL	cat.	mTPZ	Comments	Action
1	Tree of Heaven	<i>Ailanthus altissima</i>	32	F	F	F		4	5	1.8	Crack down to base, co-dominance at 5 meters with included bark (L), dead branch (L)	Remove
2	Silver Maple	<i>Acer saccharinum</i>	~80	F	F	F		12	2	4.8	Sucker around base, co-dominance at 3 meters with included bark (M), cavities (L)	Retain
3	Norway Maple	<i>Acer platanoides</i>	~80	GF	GF	G		6	2	4.8	Co-dominance at 8 meters with included bark (L), 5 meters from fence	Retain
4	Cedar edge	<i>Thuja occidentalis</i>	5 to 8	G	G	G		1		1.2		Remove
5	Manitoba Maple	<i>Acer negundo</i>	~30	F	F	FG		5	2	2.4	Co-dominance at 2 meters with included bark (L), leaning (L), asymmetrical crown (M)	Retain
6	Manitoba Maple	<i>Acer negundo</i>	~30	F	F	FG		5	2	2.4	Leaning (M), asymmetrical crown (M)	Retain
7	Manitoba Maple	<i>Acer negundo</i>	~30, ~15	F	F	F		8	2	2.4	Co-dominance at base, leaning (M).	Retain

The removal of Trees 1 and 4 will be required to accommodate the proposed development. Tree 1 located within the road right-of-way (category 5 tree); a permit will be required prior to its removal.

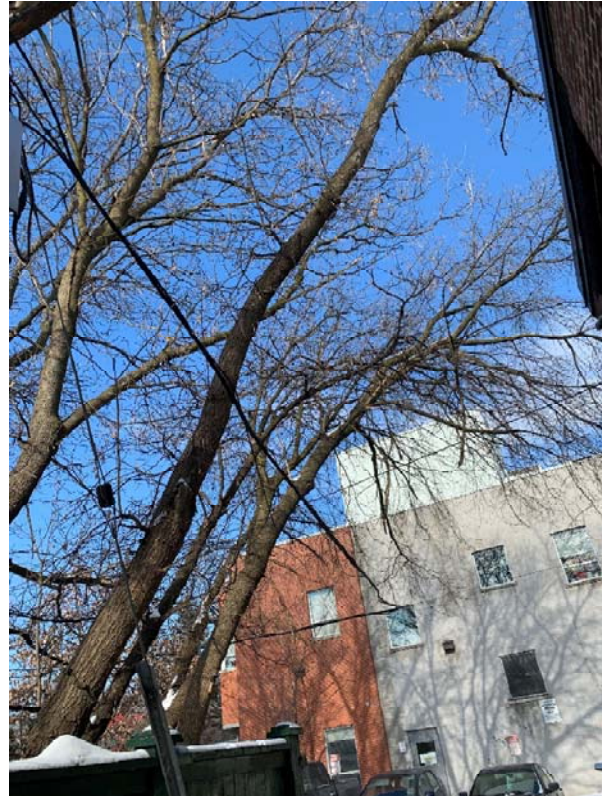
Image 6. Tree 8

8	Manitoba Maple	<i>Acer negundo</i>	~35, ~25	F	F	F		7	2	2.4	Co-dominance at base, leaning (L).	Retain
9	Eastern White Cedar	<i>Thuja occidentalis</i>	~40	GF	GF	GF		5		2.4	Co-dominance at 5 meters with included bark (L)	Retain
10	Eastern White Cedar	<i>Thuja occidentalis</i>	~25	GF	GF	GF		3		1.8	Leaning (L)	Retain
11	Tree of Heaven	<i>Ailanthus altissima</i>	~30	F	F	F		6		2.4	Co-dominance at 4 meters with included bark (L), dead branch (L), stem wounds (L), asymmetrical crown (L)	Retain
12	Norway Maple	<i>Acer platanoides</i>	~15	GF	GF	G		3		1.8	Sweep (L)	Retain
13	Norway Maple	<i>Acer platanoides</i>	~40	GF	F	GF		6		2.4	Co-dominance at 3 meters with included bark (L), leaning (L), asymmetrical crown (L)	Retain
14	White Birch	<i>Betula papyrifera</i>	26.5, 34.5	GF	GF	GF	10	5		2.4	Union at base, dead branch (L), asymmetrical crown (L)	Retain
15	Norway Maple	<i>Acer platanoides</i>	45	GF	GF	GF		12		3.0	Sweep (L), stem wounds (L)	Retain
